Home Buyers Survey Report

**1 The Road
The Town
City Centre**

Report Date: today

Date of Inspection:	6 th June 2012
----------------------------	---------------------------

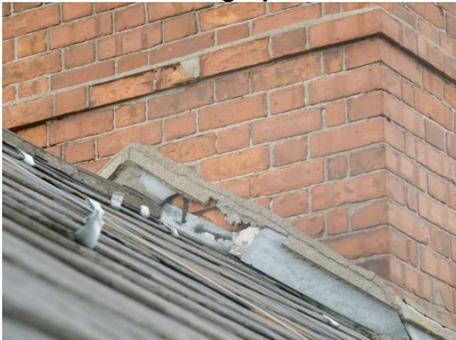
Photograph 4

The tiled flashings around the main stack are cracked and defective and should be replaced in a more durable material to reduce the risk of water penetration.

View of cracked and defective slate flashings to the main chimneystack

You should obtain quotations for repairing the chimneystack and installing proper flashings before exchange of contracts.

Chimney Stacks and Flues:- repair the chimney stack and install a proper flashing around the main stack;

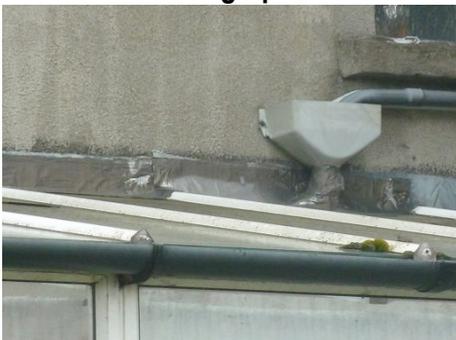
Photograph 8

These appear in satisfactory condition where visible externally. However, the self-adhesive flashing over the glazed roof will have a limited life and should be replaced in a more durable material. You should obtain quotations for installing a proper flashing before exchange of contracts.

View of inadequate temporary flashings to the conservatory roof

Roof Construction and Coverings:- re-cover the main roof and install a lining under the roof covering; repair the cracked conservatory glazed roof as found necessary; renew defective flashings over the glazed roof

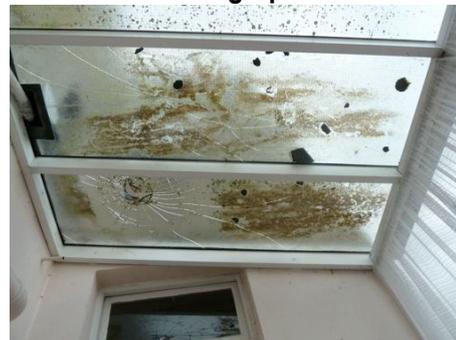
Photograph 9

The glazed lean-to conservatory roof appears in satisfactory condition, although some glass panes are broken and require renewal.

View of cracked glazing to the conservatory roof

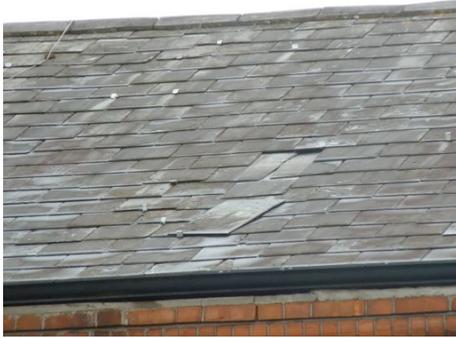
Photograph 10

View of slipped and defective slate coverings to the main roof

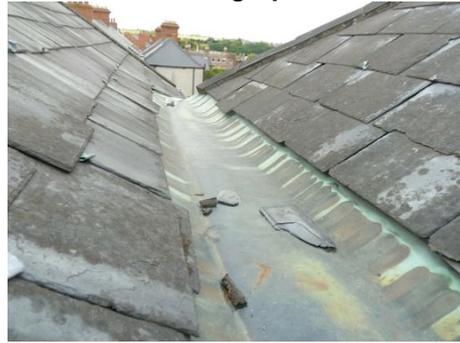
Photograph 11

The copper lined valley gutter appears in satisfactory order as there was no evidence of any leakage, or recent damp staining, internally. However, our inspection was restricted and so we cannot make any detailed comment on the gutter surfaces that were not visible. These types of gutter are often neglected and are more susceptible to disrepair and blockage. Gutter linings also tend to have a short life and can fail suddenly. Therefore, as the property has not been fully maintained in recent years, a closer inspection to check for defects is necessary.

View of the copper lined valley gutter

Hidden gutters are often neglected and as a result can fail suddenly. Therefore, regular inspection and maintenance is necessary to ensure gutters remain watertight. This should be undertaken on an annual basis.

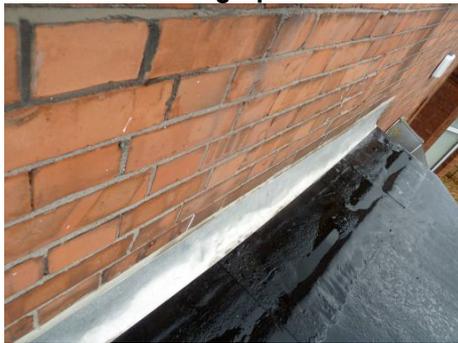
Photograph 12

The flat bay roof is covered with felt. The felt covering is old and will need replacing in the near future. Felt coverings have an average life of 10-15 years and often fail suddenly. Therefore, they will need regular repair and periodic renewal. When coverings are replaced, the supporting structure may also need some attention.

View of the felt covered bay roof

You should obtain quotations for repairing/replacing the roof covering before exchange of contracts.

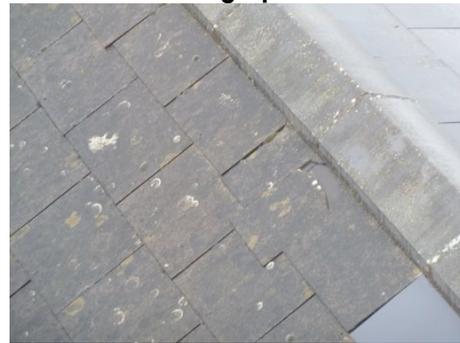
Photograph 13

To the single storey rear extension roof the asbestos based roof slates are reaching the end of their serviceable life and are covered in harmful lichen and moss. This should be removed although in the process, irreparable damage often occurs. Therefore, you should consider replacing the covering in the next several years time. Until then, the slates should not be disturbed, sanded, or drilled, without taking suitable safety precautions. When the slates are eventually replaced, licensed removal contractors will need to be employed and this could be costly. Therefore, quotations for the work should be obtained prior to exchange of contracts.

View of what appears to be asbestos based roof tiles over the rear extension

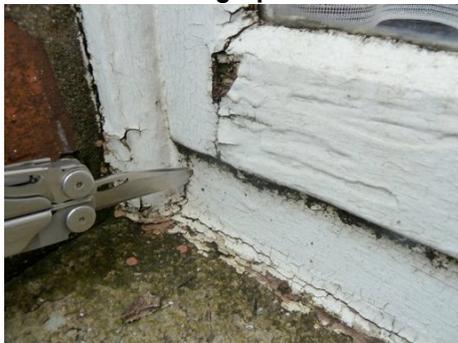
Photograph 14

There is extensive wet rot affecting the outhouse door and frame; and all timber windows and repairs, or possible replacements, are required. You should obtain quotations for repairing/replacing the windows and doors before exchange of contracts.

Typical view of a decayed timber window

External Joinery, Glazing and Decoration:- repair/replace the windows and doors;

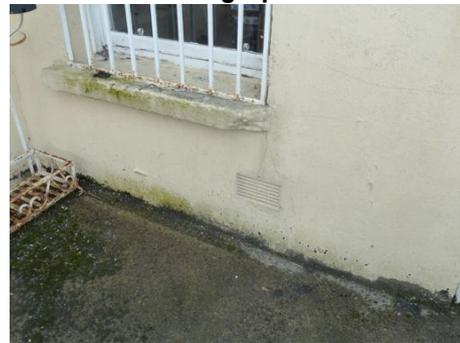
Photograph 15

We recorded high damp meter readings throughout the ground floor, which have possibly been caused by a combination of external render bridging the damp-proof course, and high external ground levels and some repairs/improvements are needed. Although a more detailed investigation is necessary prior to commencement of any remedial works.

View of high external ground levels

You should obtain quotations for lowering external ground levels, repairing the masonry, removing the render below the damp-proof course, repairing/replacing the flashings and rainwater fittings before exchange of contracts.

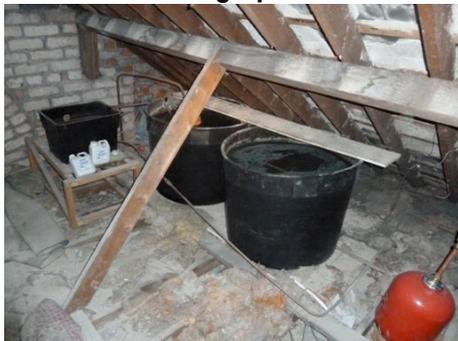
Photograph 16

The general standard of thermal insulation in this property is inadequate and you should consider the installation of double-glazing, improving insulation within the roof space, to tanks and pipes and around the hot water cylinder that will reduce heating costs. When improvements are carried out in the roof space, care should be taken not to block roof ventilation, or to cover any electrical cabling by the insulation material.

View of exposed and un-insulated cold water storage and expansion tanks

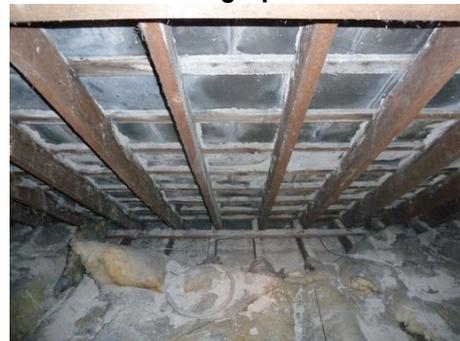
View of underside of the main roof where the lime torching has perished
